**विषय: Report of Standing Committee of Experts on Failure of 220 kV and above Voltage Class Substation Equipment failed between July 2023 to December 2024-reg.**

**REPORT OF STANDING COMMITTEE OF EXPERTS ON FAILURE OF 220 kV &  
ABOVE VOLTAGE CLASS SUBSTATION EQUIPMENT  
(July 2023 - Dec 2024)**

**GOVERNMENT OF INDIA  
MINISTRY OF POWER  
CENTRAL ELECTRICITY AUTHORITY**

**May 2025**

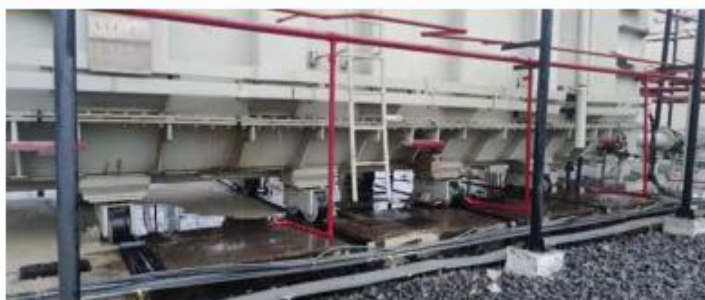
Bulging of tank and crack on stiffener toward B-phase observed after tripping of the Transformer. It resulted in oil drain from Transformer.

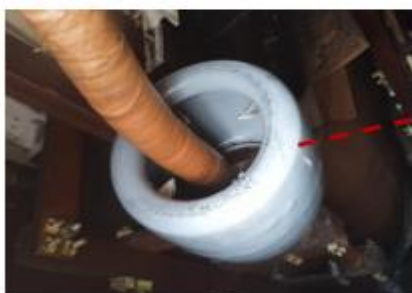
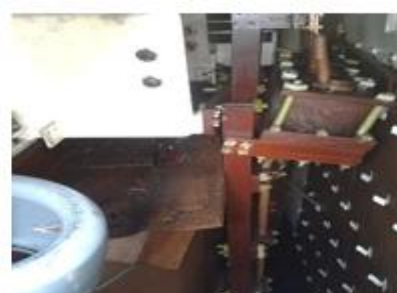
B-phase 400 kV HV Bushing shield found detached and shield mount lugs broken

NCT mounting support found broken

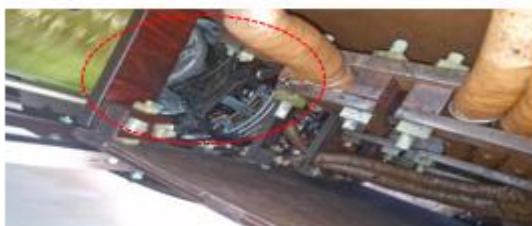
- B and Y-phase OLTC found damaged;
- B-phase selector switch mounting lug found broken;
- B-Phase selector switch displaced its mounting position;
- Y-Phase selector switch mounting lug also found broken.

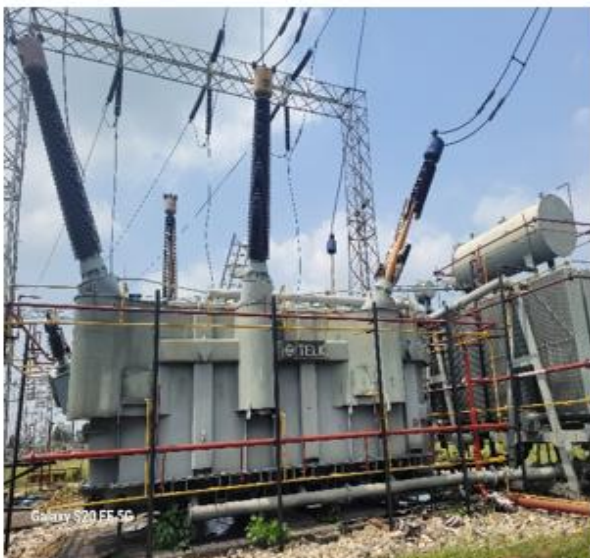
400kV B-Phase Bushing damaged

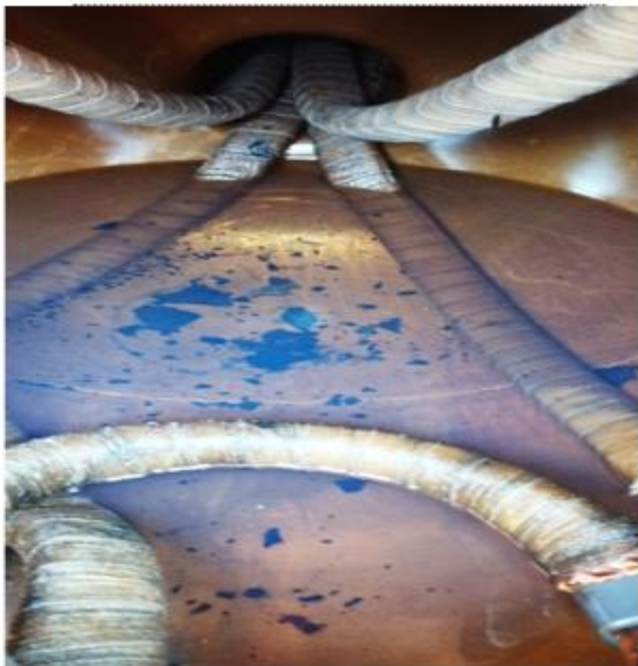
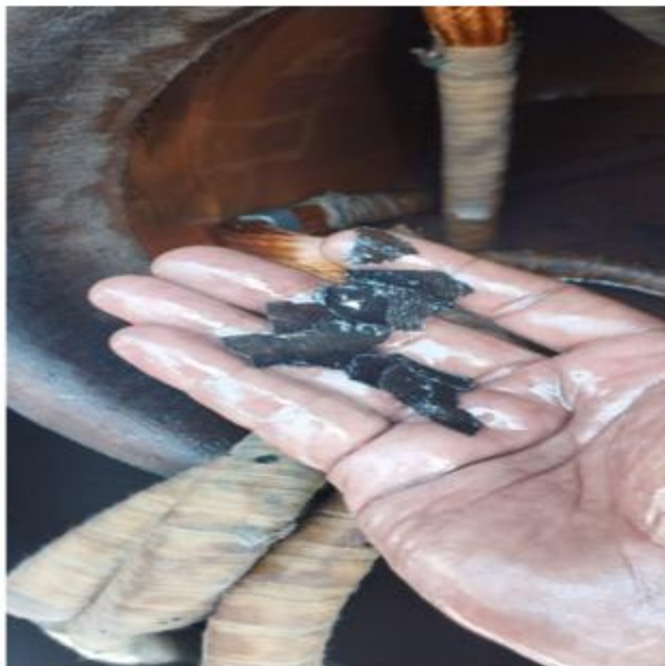
**Carbon & burnt paper on Star winding Y1 Bushing winding lead take-out area**

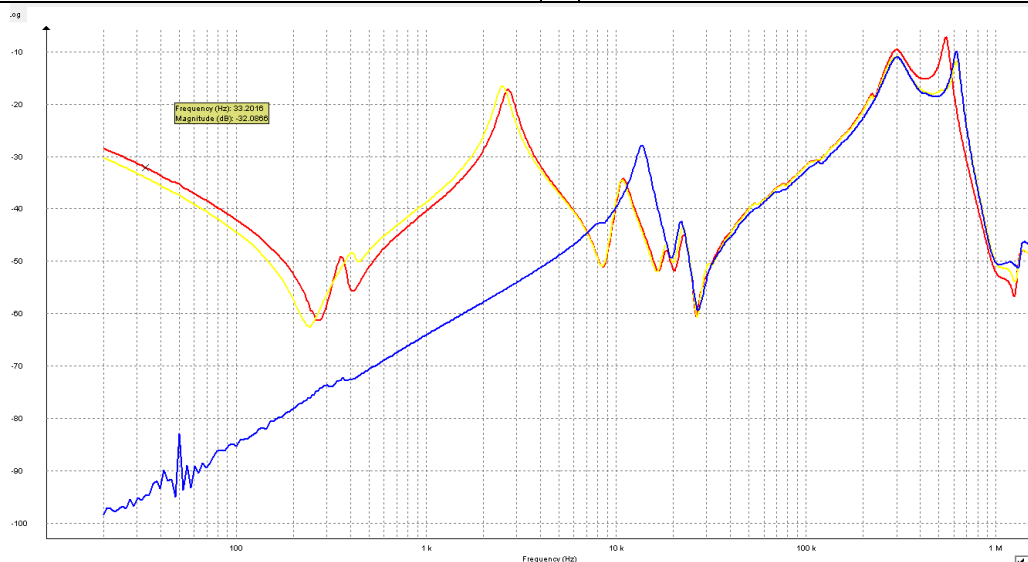
| In SFRA Signature (HV-IV open circuit), B phase open circuit signature is flat. | | | |

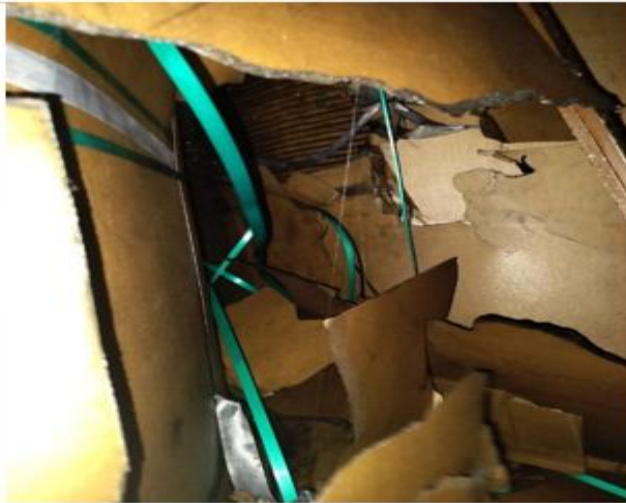
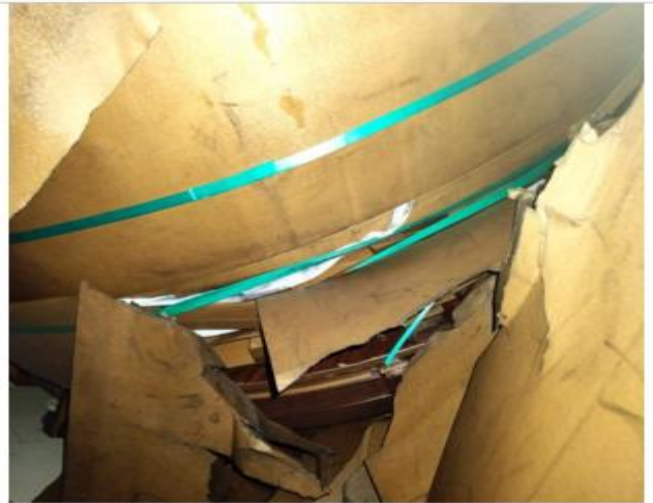
**Broken pressboard & barriers of series winding of Y & B Phase**

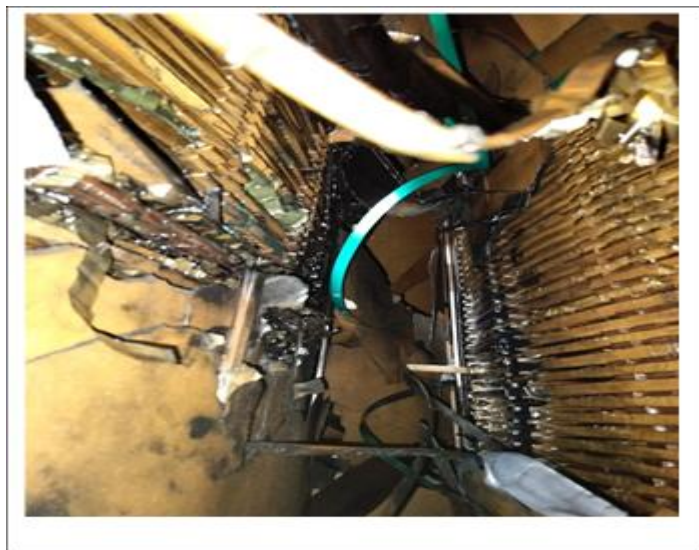
**Y-phase to B-phase Series winding fault.**

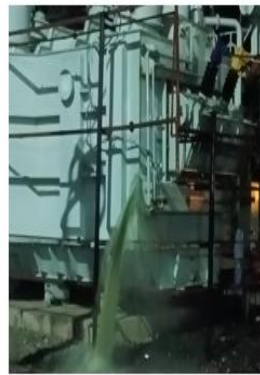
Oil gushed out

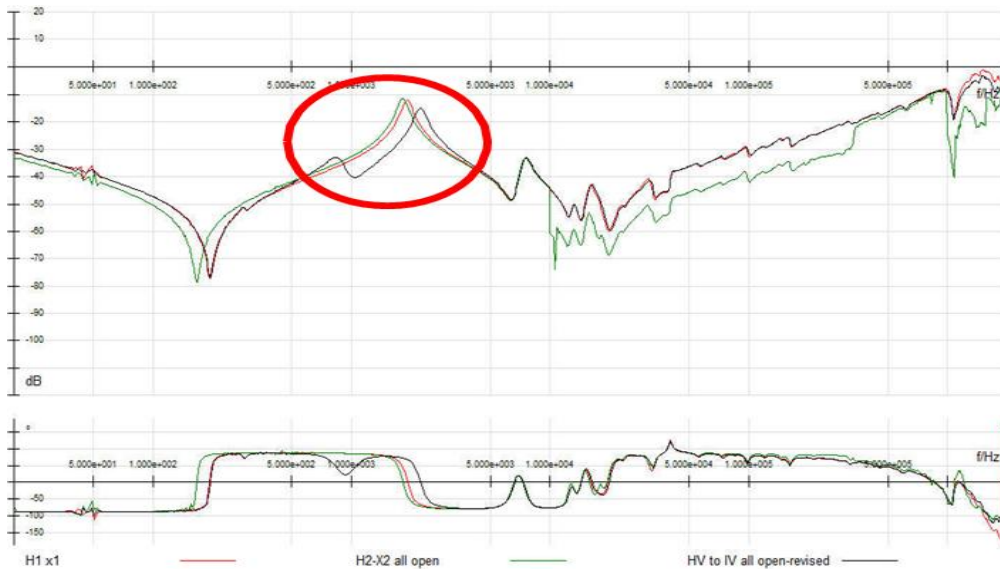
HV to IV all open condition, deviation was observed in B-ph of HV to IV at 1 kHz to 5 kHz.

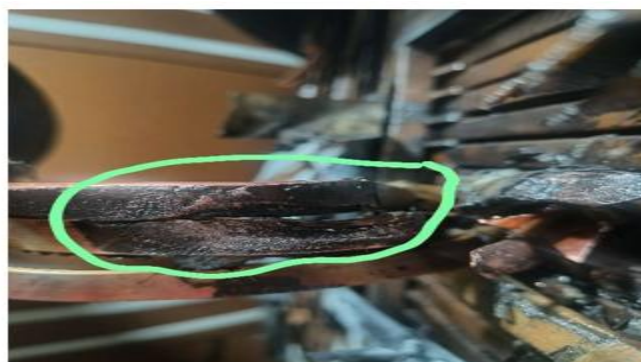
2 No's of winding conductors were melted

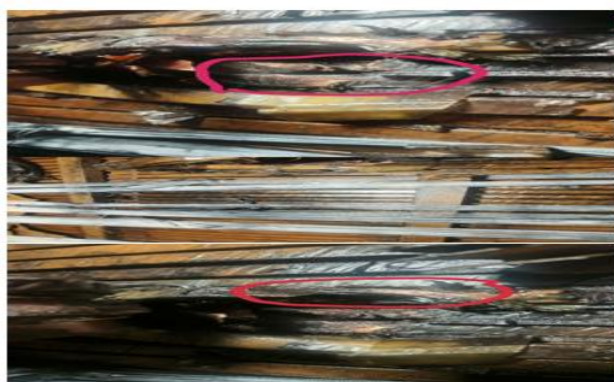
4No's disc layer conductor were found melted

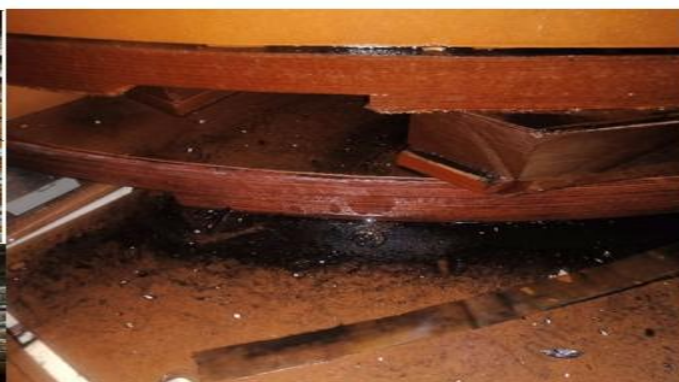
Black marks were observed on below the HV winding lead take off.

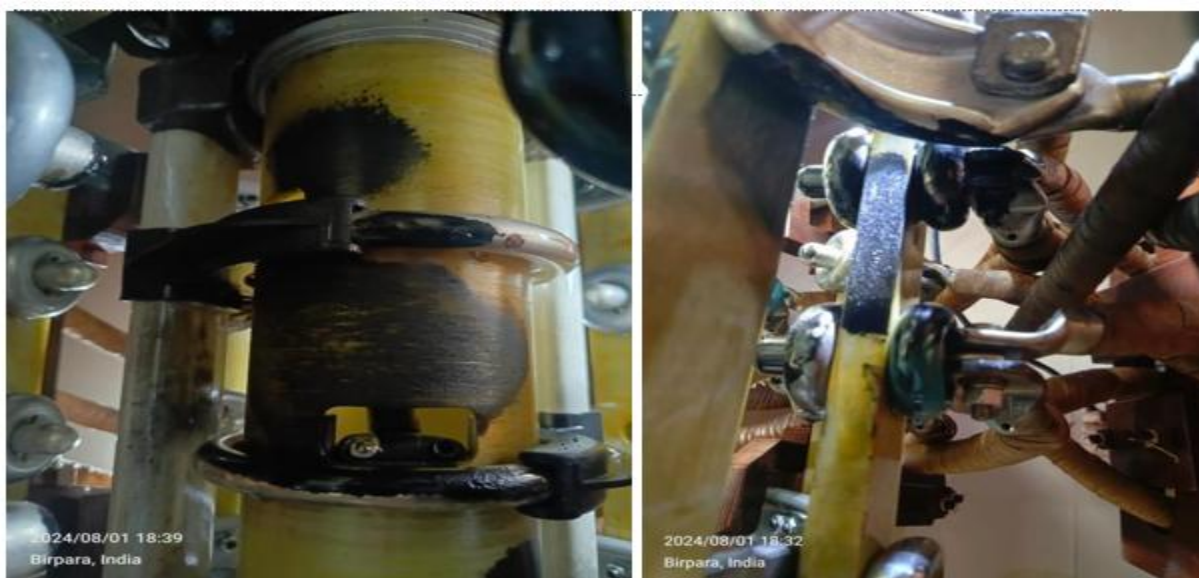
**Flash mark on Y-Ph OLTC selector switch**

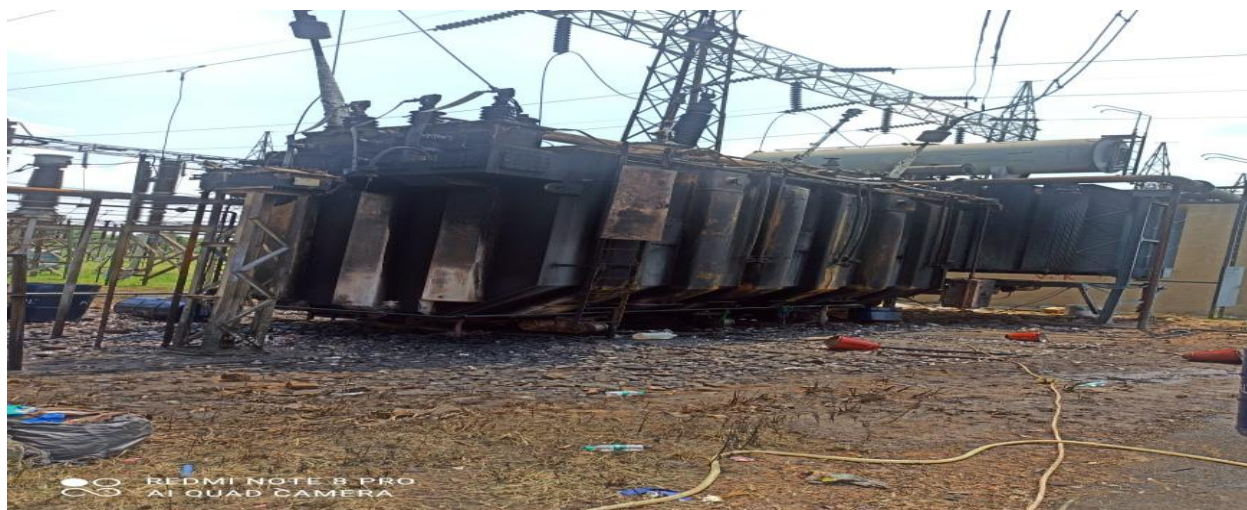
**BHEL make Transformer caught fire due to internal fault.**

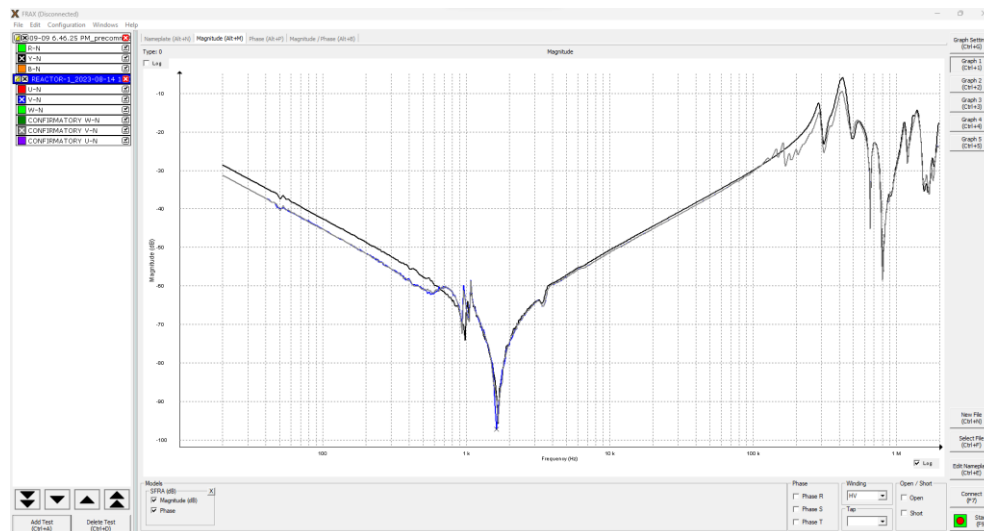
4) SFRA: Y Phase Pre-commissioning (09.09.2019) vs After fault.

Conclusion: Deviation is SFRA observed.

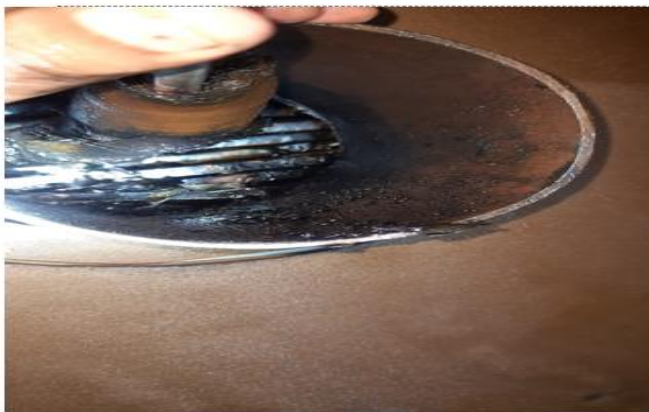
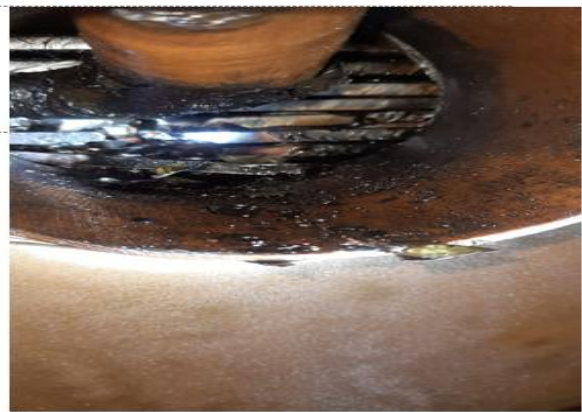
Damage at HV take-off point Y-Ph winding.

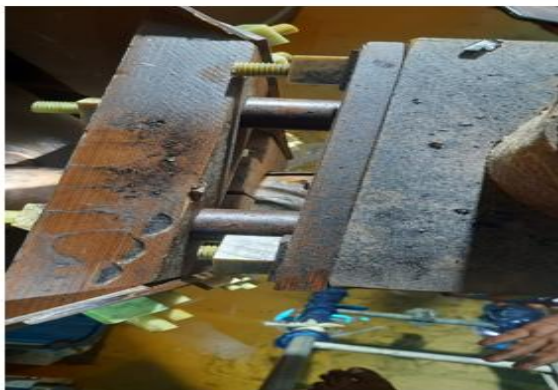
Carbon powder on lead exit support

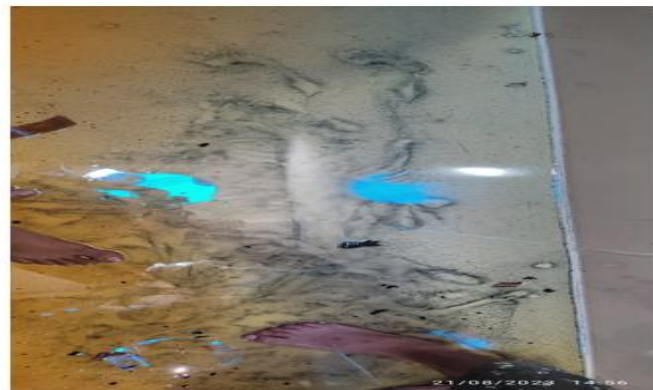
Carbon Powder on tank floor

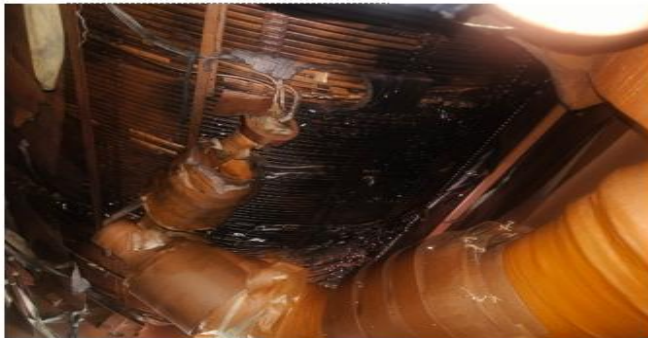
HV lead take out was found dislocated

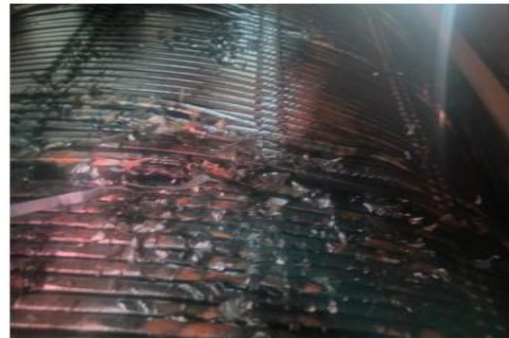
Hv winding discs were found severely burnt

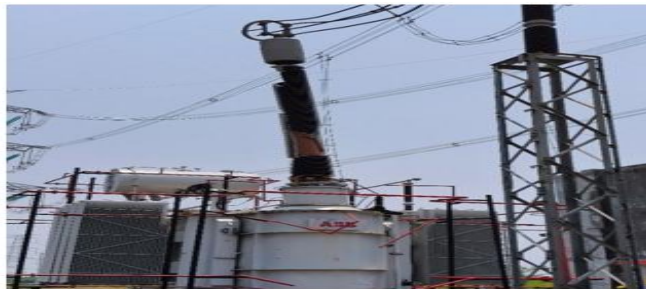
Physical damage of HV bushing

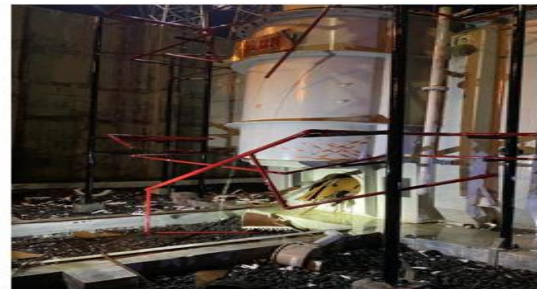
HV side inspection cover got busted and found 2mtrs away from the reactor. Also, pressboard and paper insulation were came out.

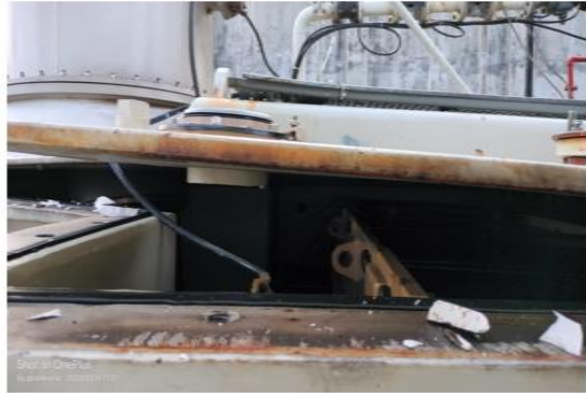
Top side main tank ruptured near HV bushing.
